LAKE LADORE DAM

NDI NO. PA-00091

WAYNE COUNTY, PENNSYLVANIA

## PHASE I INSPECTION REPORT NATIONAL DAM INSPECTION PROGRAM

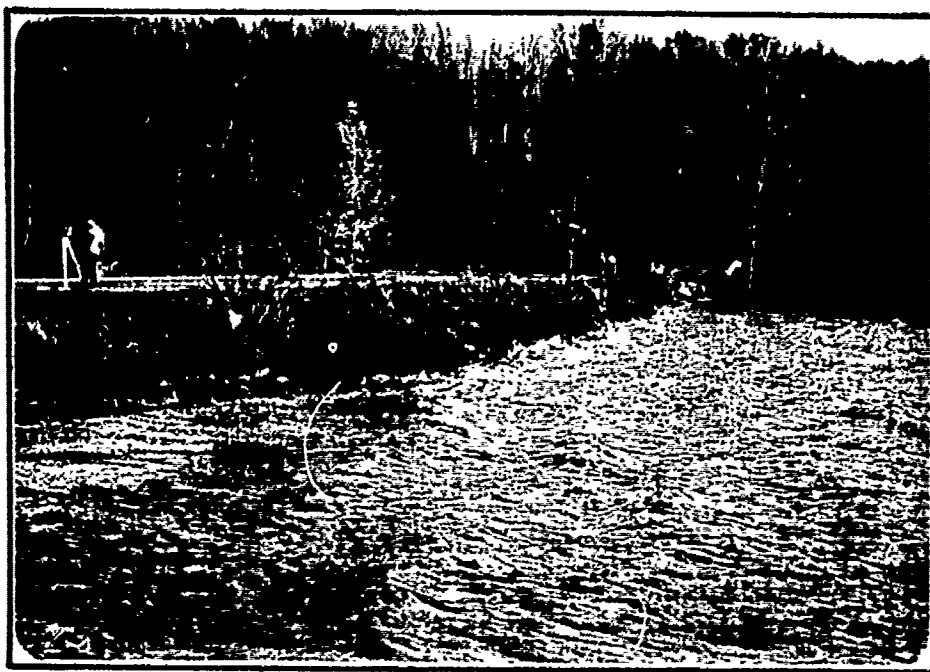
The top of the dam is well maintained. Although the upstream slope appears to be steep, good rock protection is present and no failures were detected.

UPSTREAM SLOPE - NO. 2

The operational and maintenance procedures for these facilities should be expanded to include brush removal on the upstream slope and in the spillway area. Regular observance of the upstream slope should be included in the maintenance program to ascertain that no failures in the steep rock slope has occurred. The weepholes on the downstream wall should be observed to evaluate if higher pool levels would cause fines to be washed out. A formal surveillance plan and downstream warning system should be developed for implementation during periods of high or prolonged precipitation.

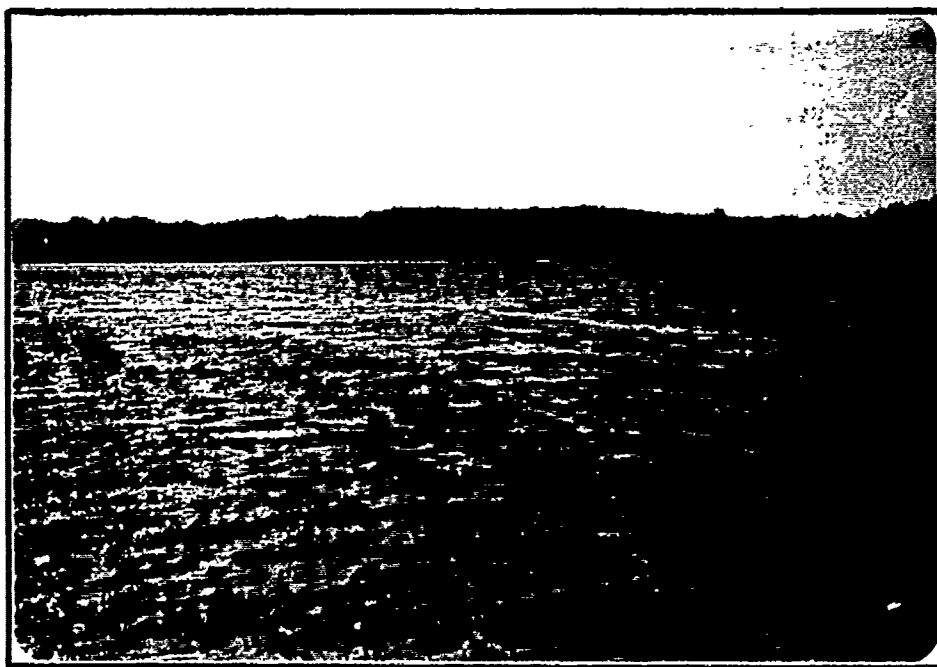
RESERVOIR AREA - NO. 3

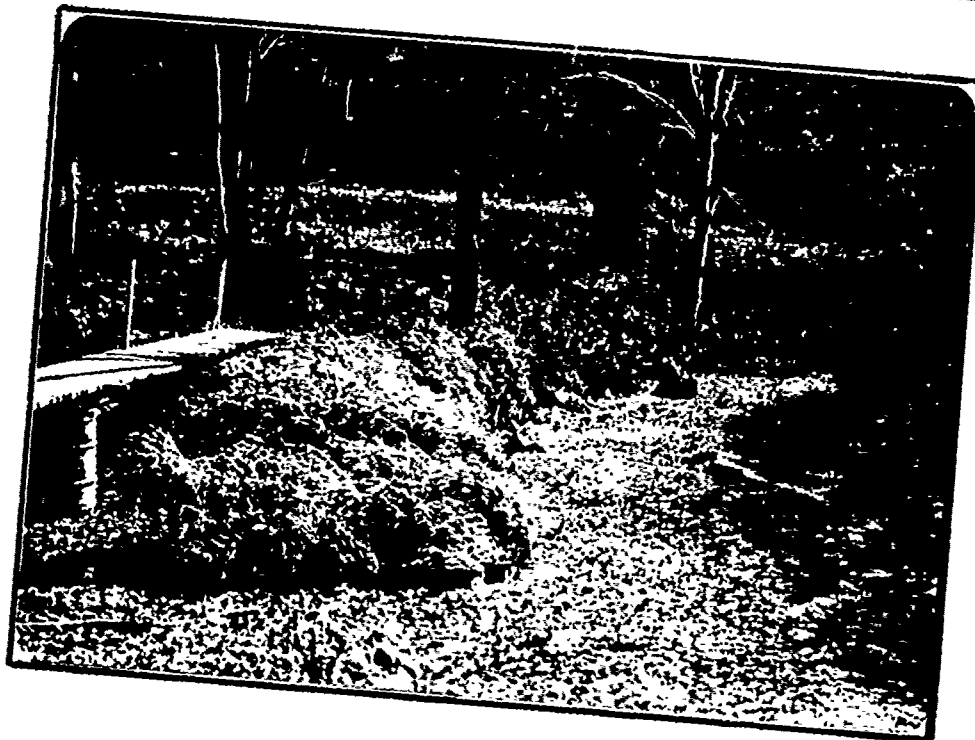
The spillway, which was added to this facility in 1922 is located in the right abutment. The approach to the spillway is directly from the reservoir. The entrance to the right side is partially obstructed by high weeds. The spillway weir is a broad crested type and not very level. There is about a 2-inch drop from right to left (See Plate A-II, Appendix A). The spillway has a concrete abutment wall on the left side and a sloped natural rock surface on the right side. The discharge channel is 118 feet long and drops at a 4 percent grade. The slab is showing some deterioration, but is in fairly good condition. The left side and the end of the discharge channel are protected with concrete walls.

SPILLWAY FOREBAY - NO. 6

2. That the spillway entrance be cleared of grass, weeds and other obstructions.
3. That the boards in the downstream valve be removed.
4. That the concrete of the right buttress be repaired and protected from further deterioration.

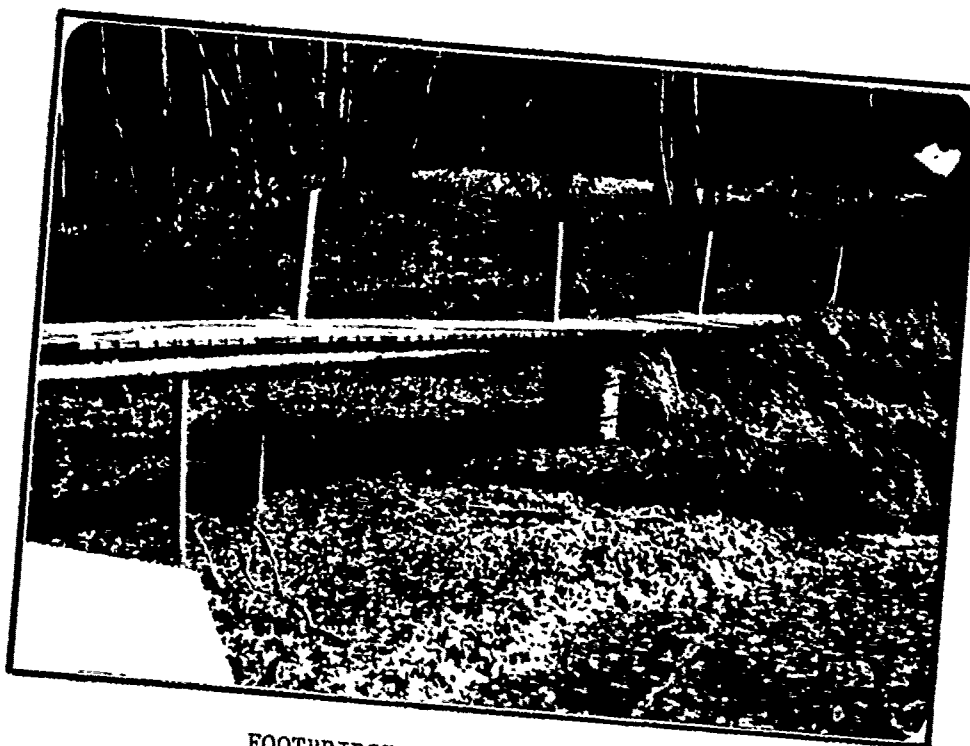
The spillway, while not entirely level, is in good condition. The entrance should be kept free of weeds and brush. The footbridge was probably placed without a permit. It appears that this bridge would be washed away during high flow and would not seriously impede the capacity of the spillway.

FOOTBRIDGE OVER SPILLWAY - NO. 7

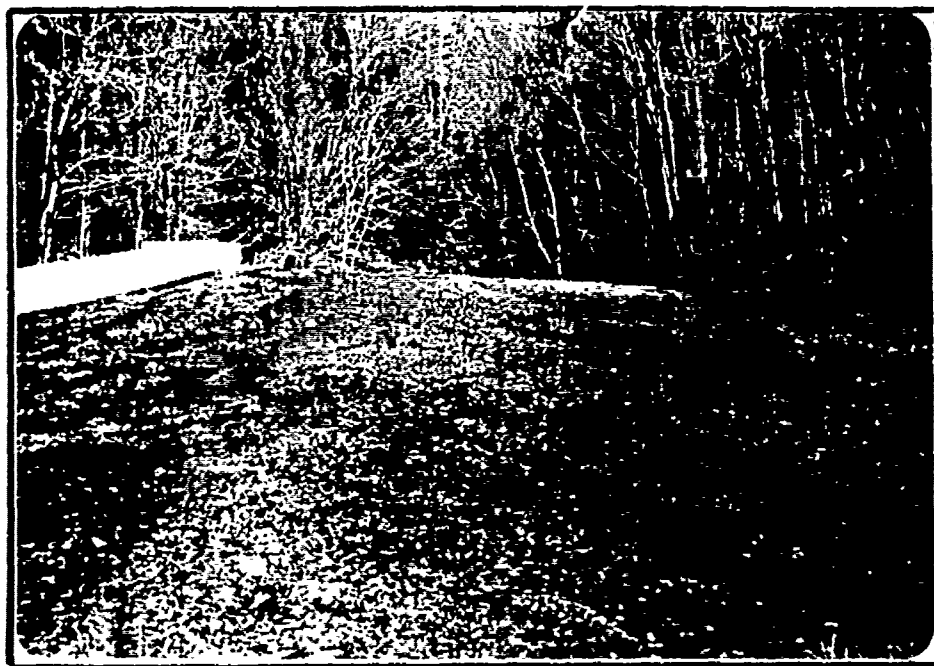
A small amount of deterioration has occurred in the spillway slab, but the overall condition of the spillway appears to be adequate at the present time. The left wall is solid and the rock surface on the right side appears sufficient to withstand expected discharges.

LOOKING DOWNSTREAM IN SPILLWAY - NO. 8
